# Stress Corrosion Behavior of 7049-T76510, -T73510 and -T73511 Aluminum Alloy Extrusions

B. T. Sanderson and W. F. Gerhold

January 1979

Prepared for  
Naval Air Systems Command  
Department of the Navy  
Washington, D.C. 20360

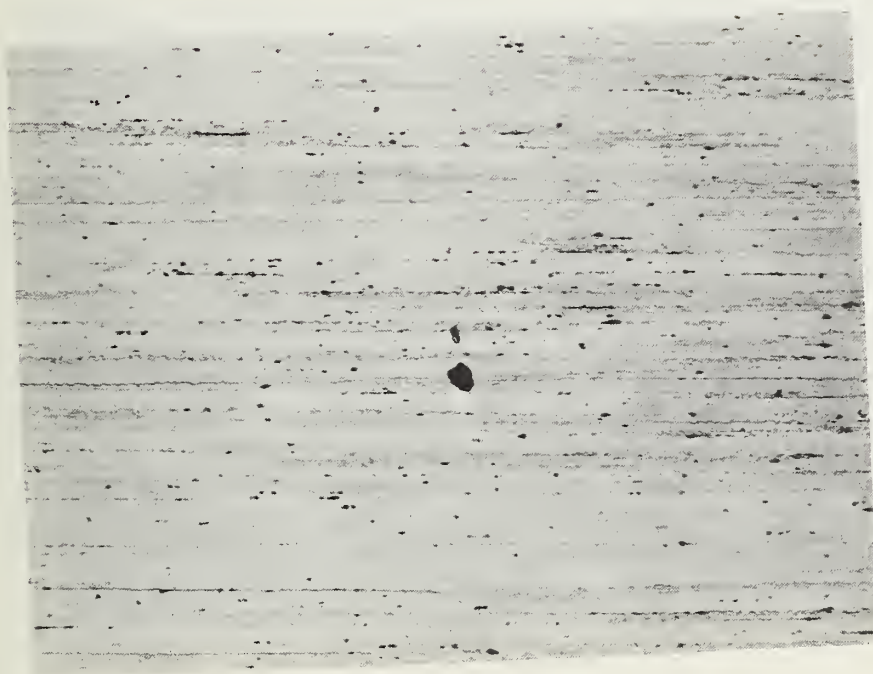
Figure 1. Microstructure of 7049-T76510 aluminum extrusion (long transverse direction). Etched, Keller's etch, X 50.

The microstructures of the three different heat treated 7049 aluminum alloy materials display similar grain size and structure. There is some evidence of recrystallization having occurred. There also appears to be some intermetallic precipitation at the grain boundaries. Photomicrographs of the materials are shown in figures 1, 2 and 3.

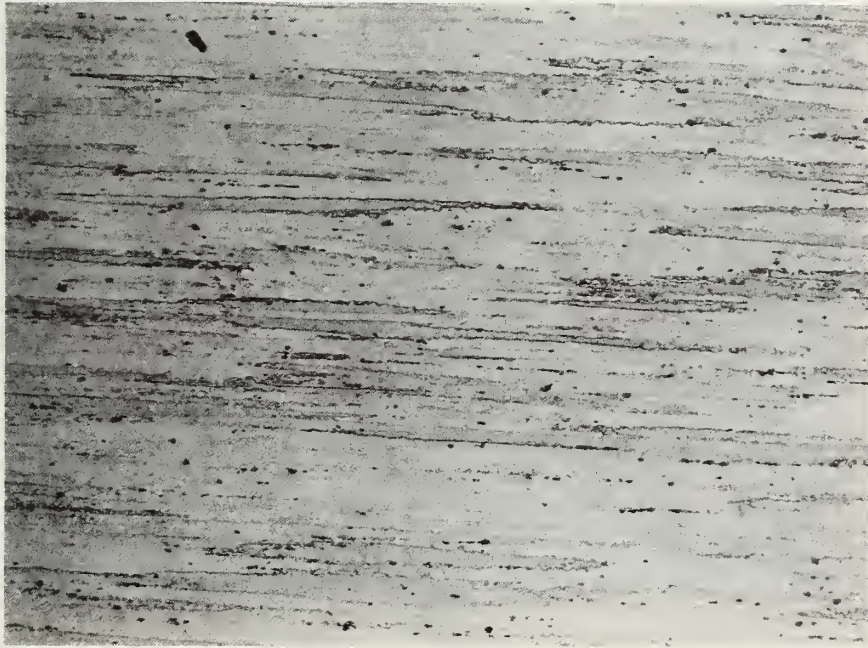
Figure 2. Microstructure of 7049-T73510 aluminum extrusion (long transverse direction). Etched, Keller's etch, X 50.

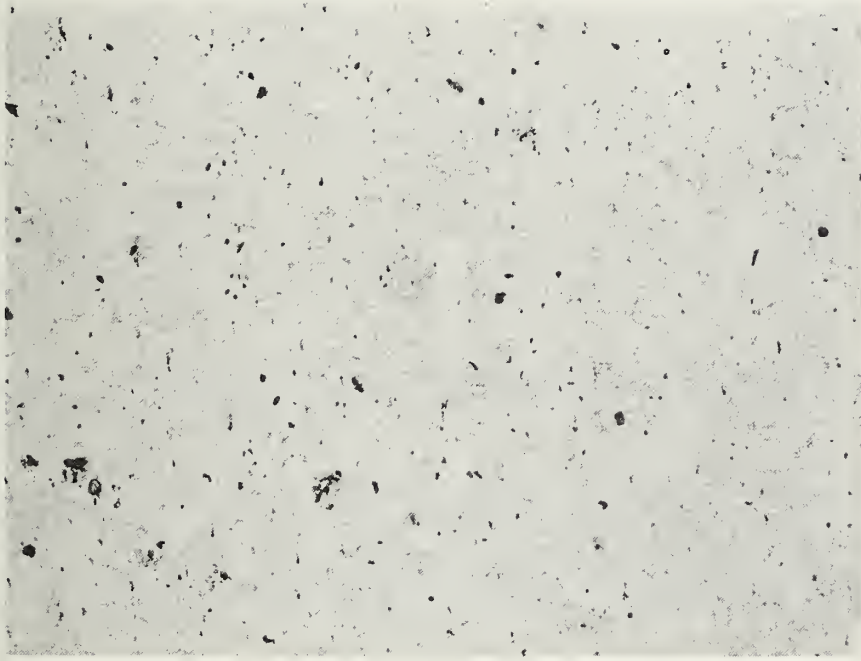
Figure 3. Microstructure of 7049-T73511 aluminum extrusion (short-transverse direction). Etched, Keller's etch, X 50.
